RCRA SAMPLING REPORT

INSPECTION DATE: May 4, 2017

SITE NAME: Container Life Cycle Management, LLC
d/b/a Mid-America Steel Drum, Inc.

EPA ID NUMBER: WIR 000 131 367

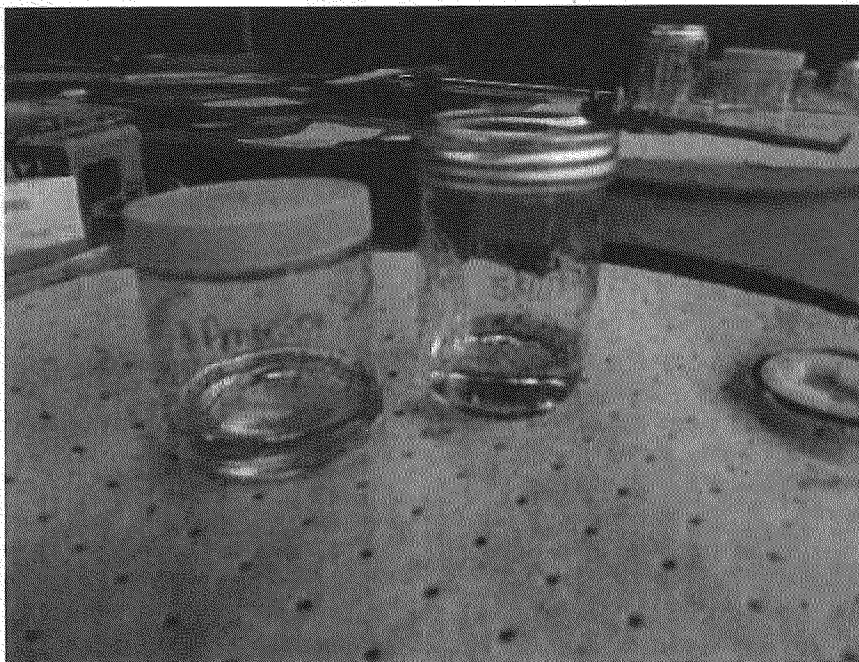
Disk Number 1
Photo Number 32
Photo Filename DSCN1092.JPG
Date/Time 5/4/2017
1:18:00 PM
Photographer Jamie Paulin

Storage of "heavies." One 55-gallon container was labeled as corrosive & flammable. SFS02. Sampled 1:20pm. Level of contents was 3 inches. pH paper showed pH of 8. 4 aliquots each sample jar. Split taken.

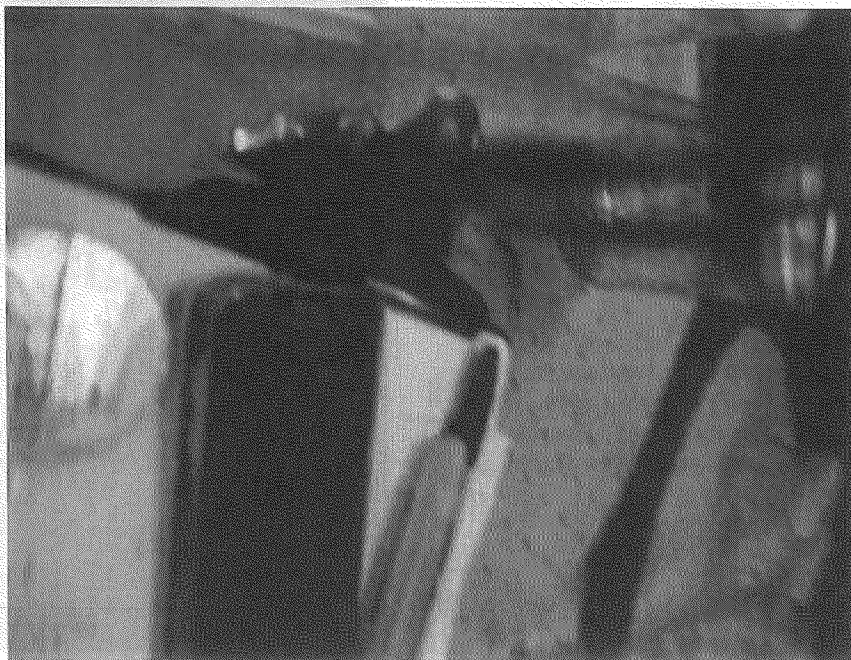
Storage of "heavies." One 55-gallon container was labeled as corrosive & flammable. SFS02. Sampled 1:20pm. Level of contents was 3 inches. pH paper showed pH of 8. 4 aliquots each sample jar. Split taken.

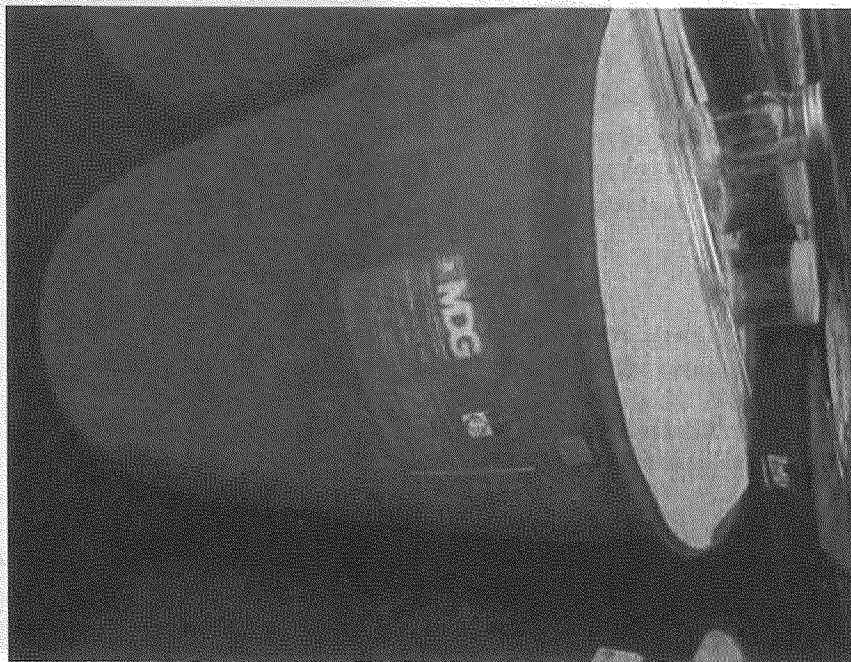
Disk Number 1
Photo Number 38
Photo Filename DSCN1098.JPG
Date/Time 5/4/2017
1:34:00 PM
Photographer Jamie Paulin

Storage of "heavies." One 55-gallon container was labeled as MDG ZymoBac GTLS 10x. SFS03. Sampled 1:31pm. Level of contents was 2.5 inches. pH paper showed pH of 6. 4 aliquots each sample jar. Split taken.

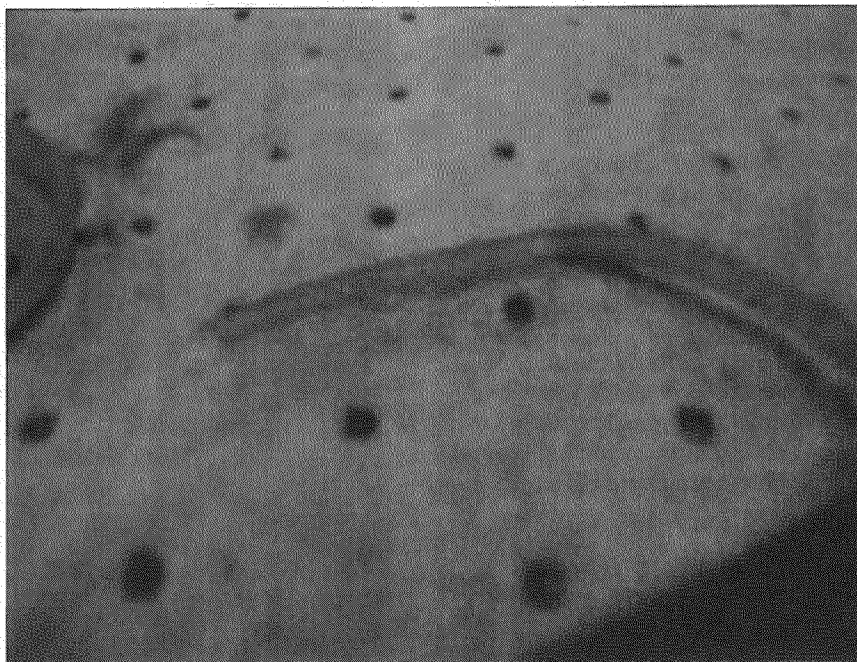
Disk Number 1
Photo Number 40
Photo Filename DSCN1100.JPG
Date/Time 5/4/2017
1:38:00 PM
Photographer Jamie Paulin

Storage of "heavies." One 55-gallon container was labeled as MDG ZymoBac GTLS 10x. SFS03. Sampled 1:31pm. Level of contents was 2.5 inches. pH paper showed pH of 6. 4 aliquots each sample jar. Split taken.

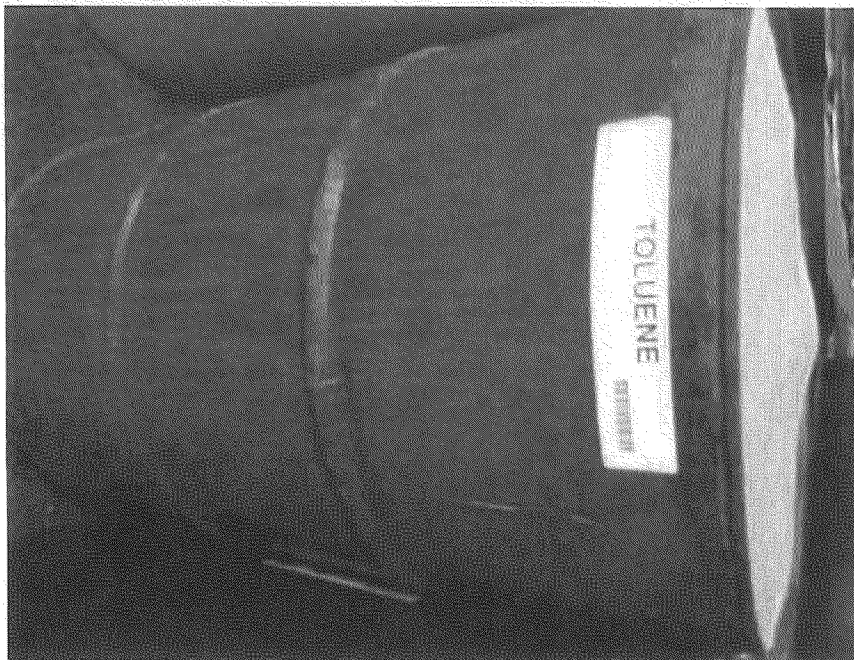
Disk Number 1
Photo Number 42
Photo Filename DSCN1102.JPG
Date/Time 5/4/2017
1:42:00 PM
Photographer Jamie Paulin

Storage of "heavies." One 55-gallon container was labeled as Toluene. SFS04. Sampled 1:39pm. Level of contents was 2 inches. pH paper showed pH of 6. 4 aliquots each sample jar. 300ppm VOCs on multi-rae. Split taken.

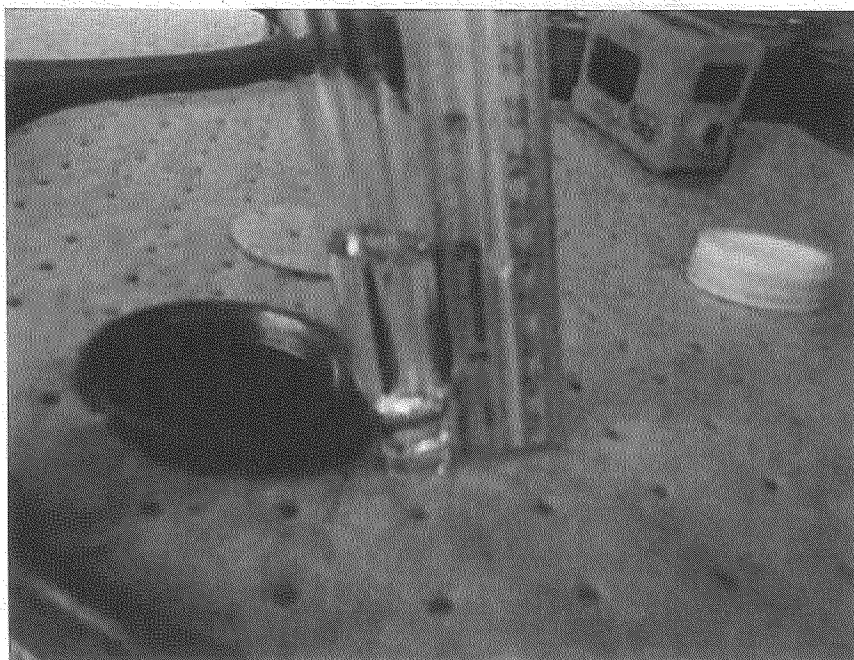
Storage of "heavies." One 55-gallon container was labeled as Toluene. SFS04. Sampled 1:39pm. Level of contents was 2 inches. pH paper showed pH of 6. 4 aliquots each sample jar. 300ppm VOCs on multi-rae. Split taken.

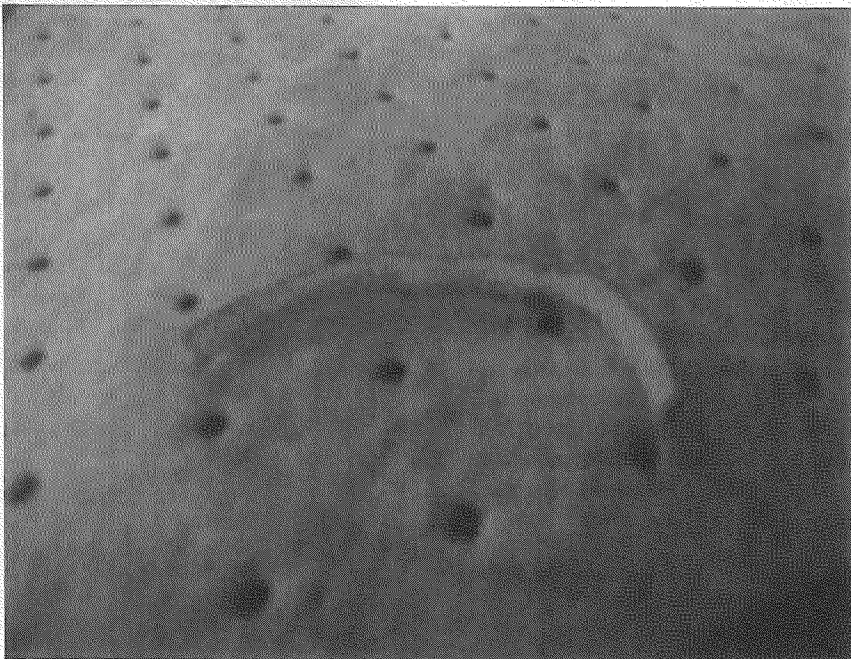
Disk Number 1
Photo Number 44
Photo Filename DSCN1104.JPG
Date/Time 5/4/2017
1:47:00 PM
Photographer Jamie Paulin

Storage of "heavies." One 55-gallon container was labeled as Toluene. SFS04. Sampled 1:39pm. Level of contents was 2 inches. pH paper showed pH of 6. 4 aliquots each sample jar. 300ppm VOCs on multi-rae. Split taken.

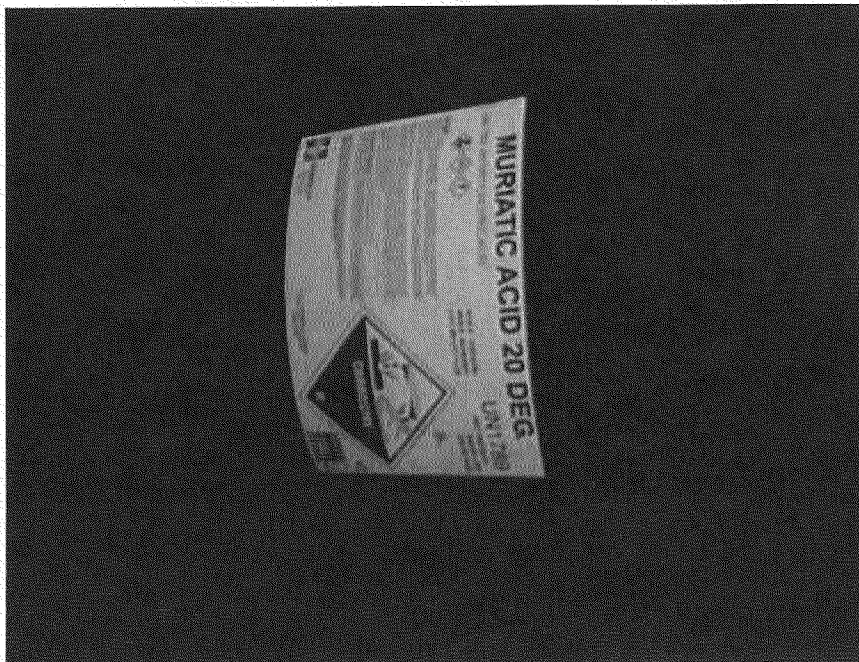
Disk Number 1
Photo Number 46
Photo Filename DSCN1106.JPG
Date/Time 5/4/2017
1:51:00 PM
Photographer Jamie Paulin

Storage of "heavies." One 55-gallon container was labeled as Muriatic Acid. SFS05. Tried to sample at 1:46pm. When drum was opened, the drum began to fume/smoke. We did not take a sample for safety purposes. The fumes turned the pH paper red, pH of 1.

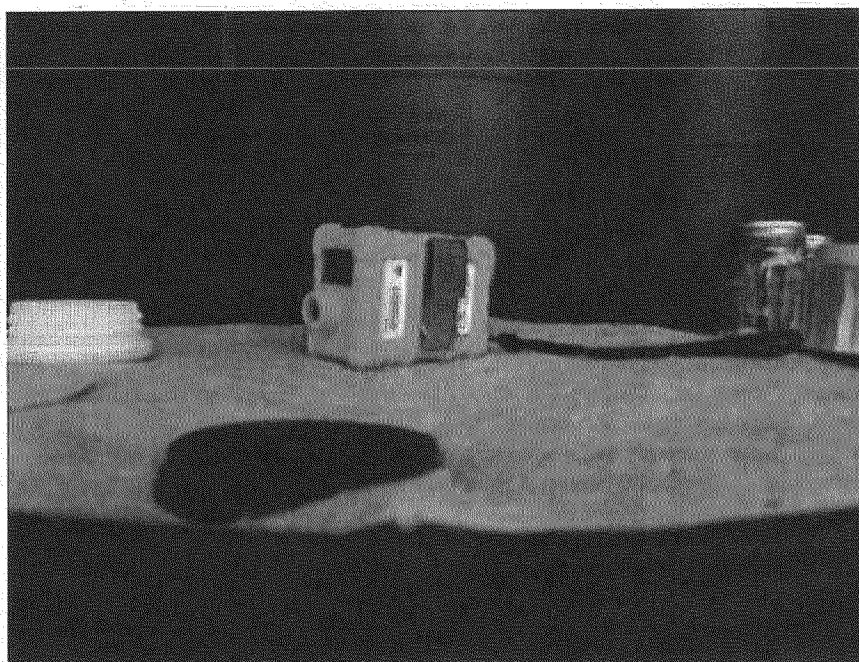
Storage of "heavies." One 55-gallon container was labeled as Muriatic Acid. SFS05. Tried to sample at 1:46pm. When drum was opened, the drum began to fume/smoke. We did not take a sample for safety purposes. The fumes turned the pH paper red, pH of 1.

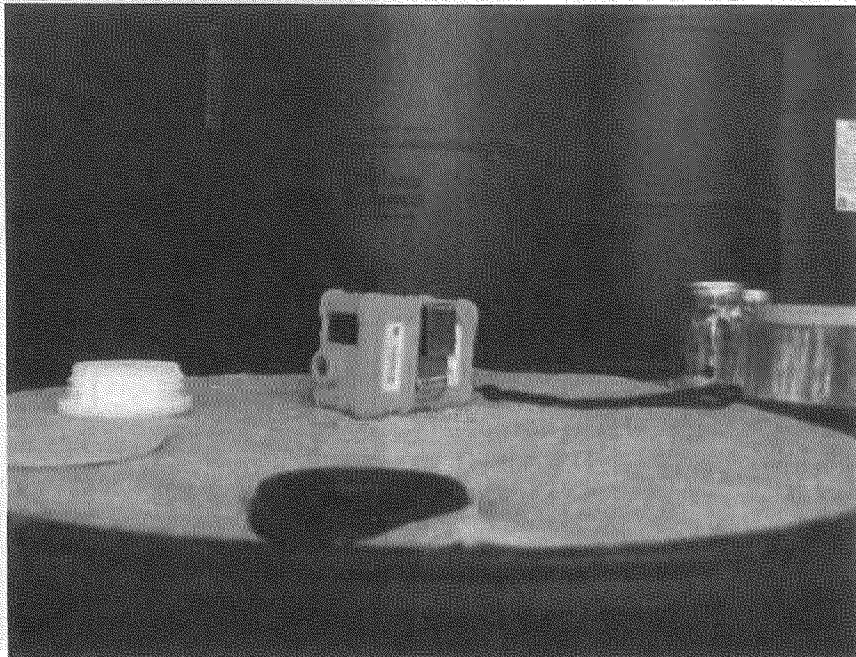
Disk Number 1
Photo Number 48
Photo Filename DSCN1108.JPG
Date/Time 5/4/2017
1:52:00 PM
Photographer Jamie Paulin

Storage of "heavies." One 55-gallon container was labeled as Muriatic Acid. SFS05. Tried to sample at 1:46pm. When drum was opened, the drum began to fume/smoke. We did not take a sample for safety purposes. The fumes turned the pH paper red, pH of 1.

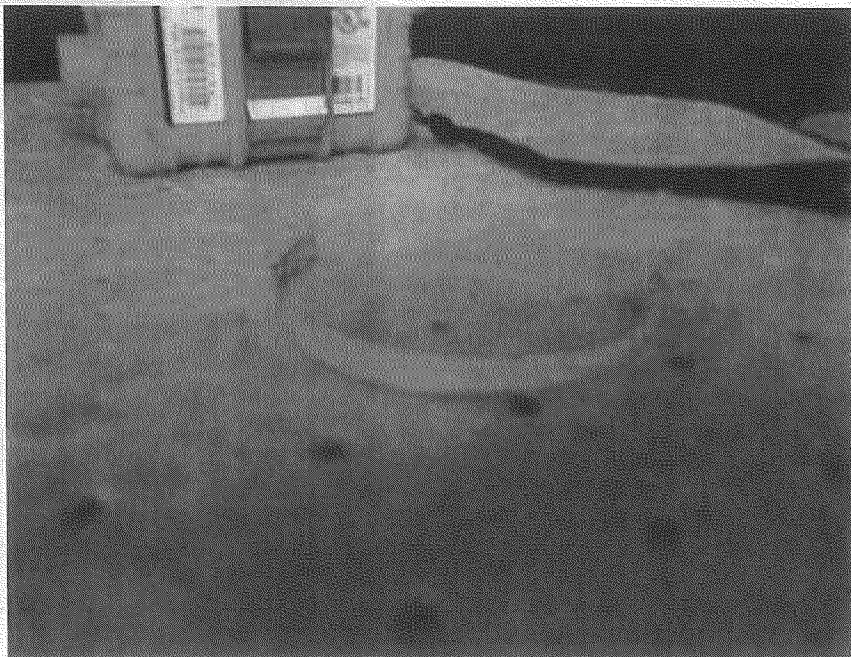
Storage of "heavies." One 55-gallon container was labeled as Muriatic Acid 20 DEG. SFS06. Sampled 1:55pm. Level of contents was 3.2 inches. pH paper showed pH of 1.4 aliquots each sample jar. Split taken.

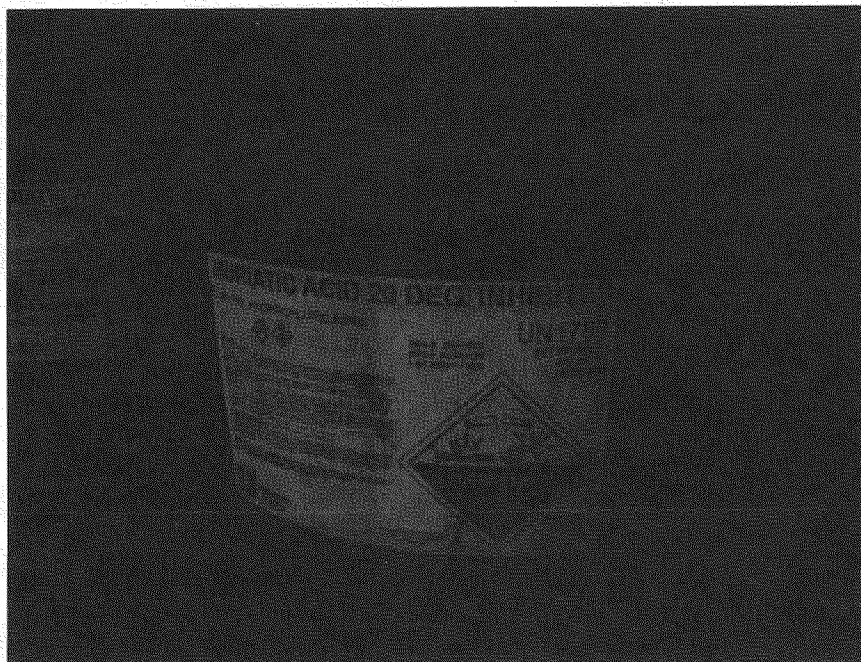
Disk Number 1
Photo Number 50
Photo Filename DSCN1110.JPG
Date/Time 5/4/2017
1:58:00 PM
Photographer Jamie Paulin

Storage of "heavies." One 55-gallon container was labeled as Muriatic Acid 20 DEG. SFS06. Sampled 1:55pm. Level of contents was 3.2 inches. pH paper showed pH of 1.4 aliquots each sample jar. Split taken.

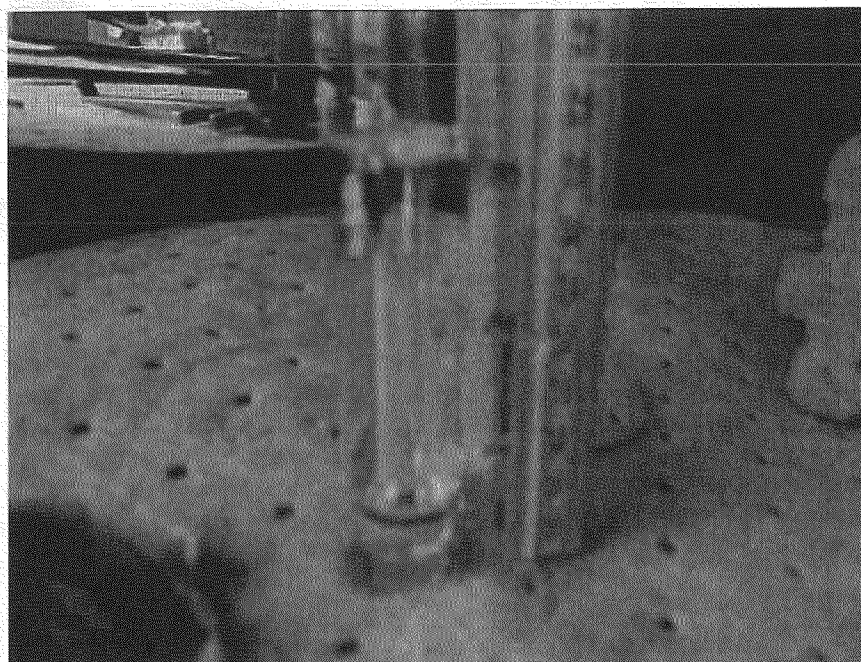
Storage of "heavies." One 55-gallon container was labeled as Muriatic Acid 20 DEG. SFS06. Sampled 1:55pm. Level of contents was 3.2 inches. pH paper showed pH of 1. 4 aliquots each sample jar. Split taken.

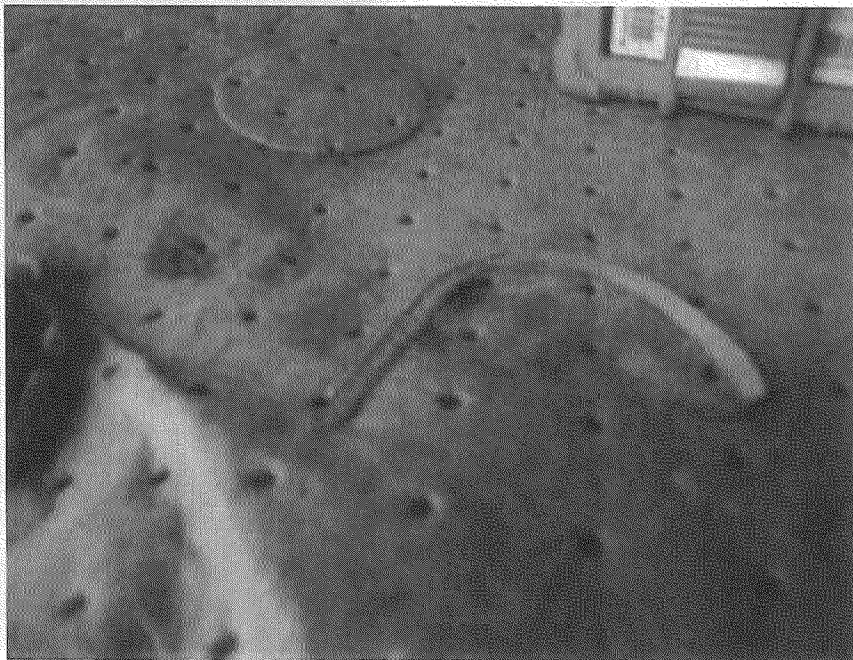
Disk Number 1
Photo Number 52
Photo Filename DSCN1112.JPG
Date/Time 5/4/2017
2:03:00 PM
Photographer Jamie Paulin

Storage of "heavies." One 55-gallon container was labeled as Muriatic Acid 20 DEG. SFS06. Sampled 1:55pm. Level of contents was 3.2 inches. pH paper showed pH of 1. 4 aliquots each sample jar. Split taken.

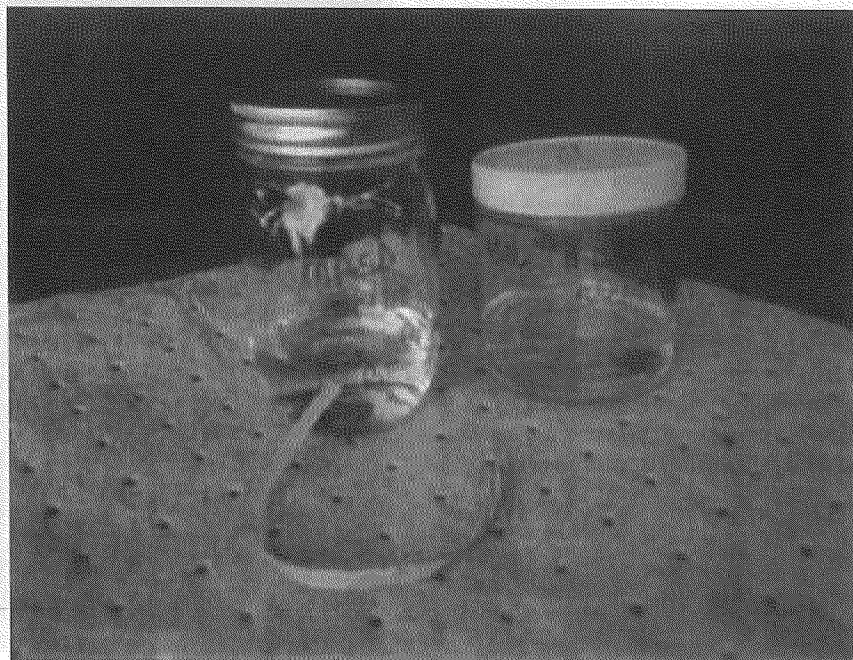
Storage of "heavies." One 55-gallon container was labeled as ETOH/Triethyl Citrate Kosher. SFS07. Sampled 2:03pm. Level of contents was 2.75 inches. pH paper showed pH of 6. 4 aliquots each sample jar. Split taken.

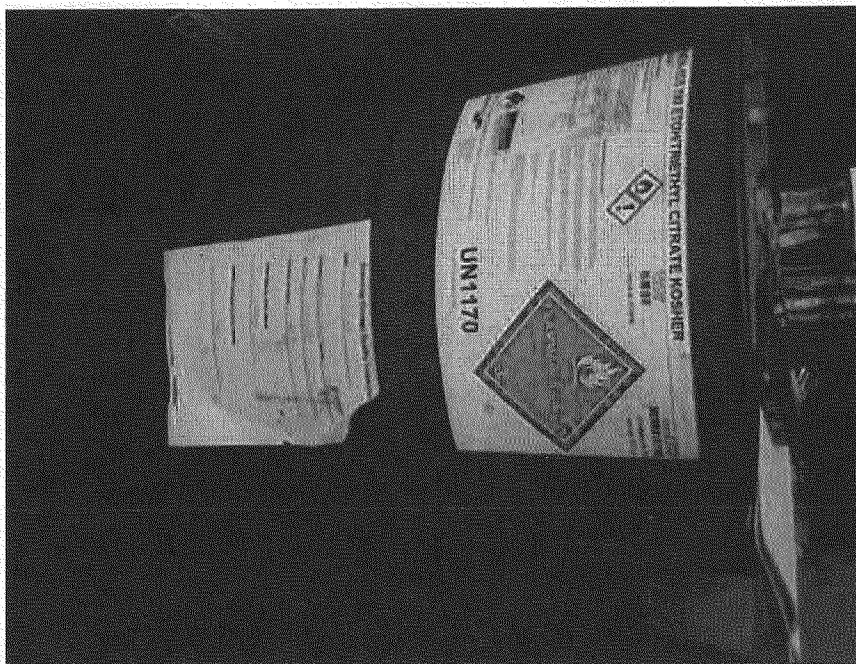
Disk Number 1
Photo Number 54
Photo Filename DSCN1114.JPG
Date/Time 5/4/2017
2:07:00 PM
Photographer Jamie Paulin

Storage of "heavies." One 55-gallon container was labeled as ETOH/Triethyl Citrate Kosher. SFS07. Sampled 2:03pm. Level of contents was 2.75 inches. pH paper showed pH of 6. 4 aliquots each sample jar. Split taken.

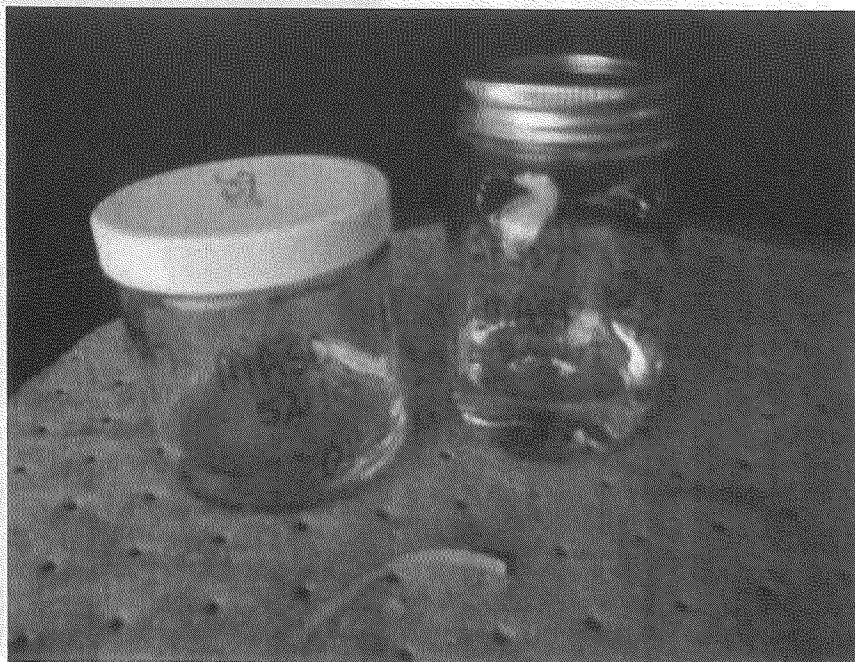
Disk Number 1
Photo Number 56
Photo Filename DSCN1116.JPG
Date/Time 5/4/2017
2:56:00 PM
Photographer Jamie Paulin

Storage of "heavies." One 55-gallon container was labeled as Non Hazardous Waste. SFS08. Sampled 3:10pm. Full contents. pH paper showed pH of 10. 8 aliquots each sample jar. 4 x 16 oz sample jars were filled. Split taken.
